**Flood Control Project Maintenance
Levee Inspections**
LMA District Cover Sheet
Spring 2018 Levee Inspection Results

Sacramento Maintenance Yard Maintenance Area 0009

Spring 2018 Levee Inspection Results

Waterway	Bank	Unit Miles
Unit No. 01 Sacramento River	Left	19.35

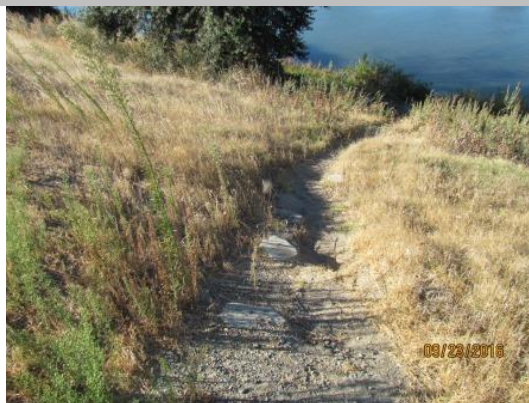
Photo 1 of 1 : SP_2018_MA0009_201_254_20180306_00205.jpg

LM Start	12.83	Rating **	A/W	Issue No.	254
LM End	12.83	Issue Type +	Ma	Location *	WS
Category	Earthen Levee			GPS Latitude/Longitude	
				Start	End
Item	Slope Stability			38.428881 °	38.428881 °
				-121.530829 °	-121.530829 °
DWR ID	DWR_MA0009_01_f_2016_254				
Comment Code					
S2 : Repair the levee slope damaged by foot traffic and prevent access where possible.					
Inspector Comment

Path made due to foot traffic. May cause slope stability issues. Stepping stones put in the ground. Fall 2016.

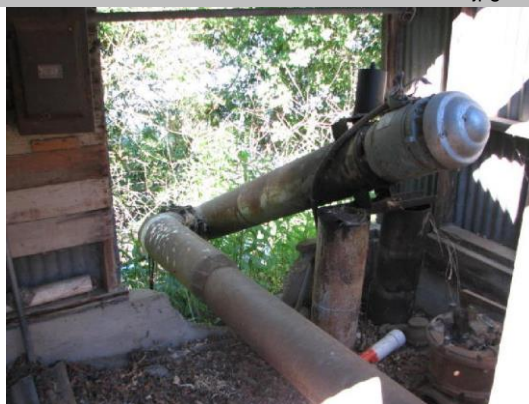
Photo 3 of 3 : UCIP_SP_2018_51464_20797.jpg

Item	DWR UCIP Field Study			38.421394 °	38.421394 °	
				-121.524955 °	-121.524955 °	
DWR ID						
Comment Code						
Inspector Comment						
FS_ID:51464 DS_ID:17469 EP_NO: N/A Repair Type: Urgent Crossing Status: Found UCIP Comments: 12/02/2016 same as previous inspection recommend internal integrity inspection to determine condition of pipe through the levee. Need to contact owner to dermine status of crossing. If crossing is still in use or is no longer in use, owner will need to coordinate with the CVFPB to comply with Title 23. (O. Magana - DWR UCIP)06/25/2012 Pipe has leaks between valve and levee crown on both sides of levee. Ineffective repairs have been made. This pipe is an excellent candidate for video inspection. (W. Wylie - DWR UCIP) FIELD_STRUCT_DESC: 10-inch steel irrigation pipe through levee, 4.8 feet below crown. Pump in pump house located on the waterside (WS) slope, stairs located on both slopes. Gate valves on both ends. Service pole located on the landside (LS) slope. [Additional Reference(s): DWR Levee Log, 1991. USACE Sacramento O&M Manual Unit 111, May 1959, (River Mile 42.36)]. FS Date: 12/2/2016

Holes/leaks in pipe on WS of Pumphouse.

Slant pump in pumphouse.

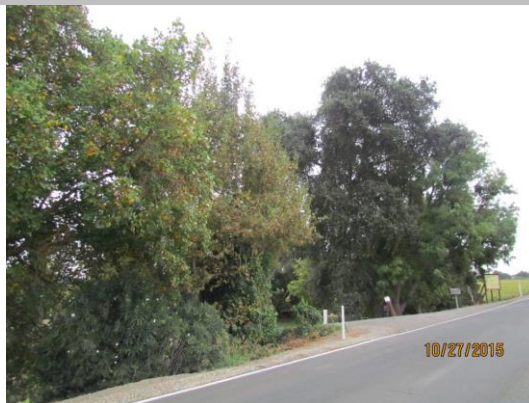
Photo 1 of 1 : SP_2018_MA0009_201_206_20180306_00157.jpg

LM Start	13.45	Rating **	M	Issue No.	206
LM End	13.45	Issue Type +	En	Location *	LS
Category	Earthen Levee			GPS Latitude/Longitude	
				Start	End
Item	Vegetation			38.421183 °	38.421183 °
				-121.524747 °	-121.524747 °
DWR ID	DWR_MA0009_01_s_2012_206				
Comment Code					
V6 : Landscaping					
Inspector Comment

View of the trees on the landward side of the levee looking downstream. Fall 2015.

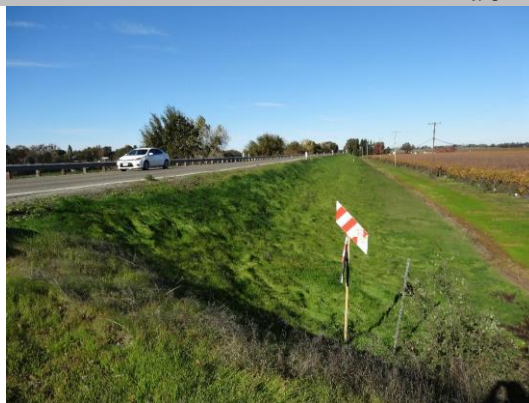
Photo 1 of 3 : UCIP_SP_2018_51260_76342.jpg

Comment Code					
Inspector Comment					
FS_ID:51260 DS_ID:17471 EP_NO: N/A Repair Type: Urgent Crossing Status: Not Found UCIP Comments: 12/02/2016 Multiple PG&E markers were found along the LS toe. Line runs along LS toe for several miles and splits off main line at multiple locations. Need to coordinate with owner to determine where pipe crosses levee. Need to coordinate with PG&E to determine if crossing goes through the levee or if line goes along LS toe only. (O. Magana - DWR UCIP)06/25/2012 Pipe not found and no markers found. Further investigation should be conducted to locate gasoline. (W. Wylie - DWR UCIP) FIELD_STRUCT_DESC: 6-inch high pressure gas line of unknown material through levee and across the channel at an unknown depth. [Additional Reference(s): DWR Levee Log, 1991]. FS Date: 12/2/2016

View of PG&E markers located where pipe is assumed to be.

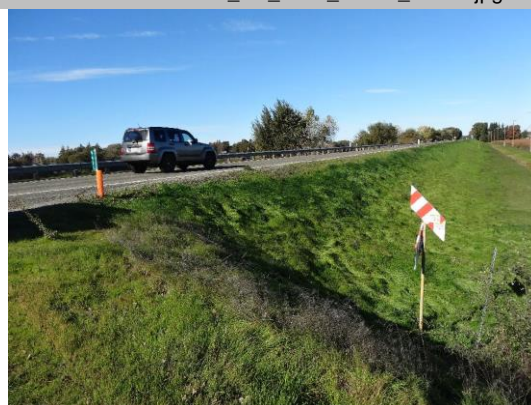
Photo 3 of 3 : UCIP_SP_2018_51260_76344.jpg

LM Start	13.70	Rating **	U	Issue No.	1822 (cont)
LM End	13.70	Issue Type +	En	Location *

View of levee crown at crossing.

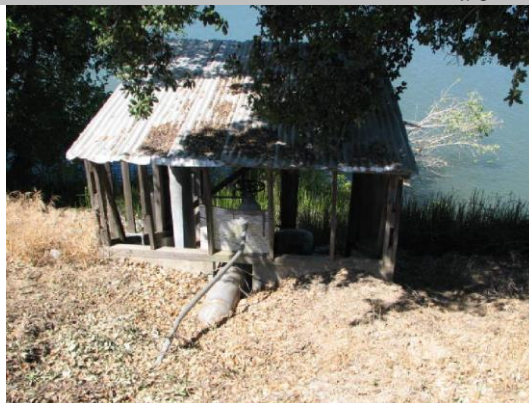
Photo 1 of 3 : UCIP_SP_2018_5172_6983.jpg

LM Start	13.85	Rating **	M	Issue No.	1823
LM End	13.85	Issue Type +	En	Location *	
Category	Supplemental			GPS Latitude/Longitude	
				Start	End
Item	DWR UCIP Field Study			38.416180 °	38.416180 °
				-121.521083 °	-121.521083 °
DWR ID					
Comment Code					
Inspector Comment					
FS_ID:5172 DS_ID:17474 EP_NO: N/A Repair Type: Non-Urgent Crossing Status: Found UCIP Comments: Rodent undermining pipe on LS slope. Need to fill burrow with flowable fill. FIELD_STRUCT_DESC: 14-inch pipe through levee, 5.2 feet below crown. 12-inch sleeved through 14-inch with annular space grouted. Pump and gate valve in pump house on waterward slope. Service pole on landward slope. 36-inch steel standpipe at toe of landward slope. Originally included in O+M manual (1955). 1.5-inch steel electrical conduit through levee and parallel to 14-inch pipe. FS Date: 6/25/2012 10:08:16 AM

Pump and gate valve in pumphouse on WS slope.

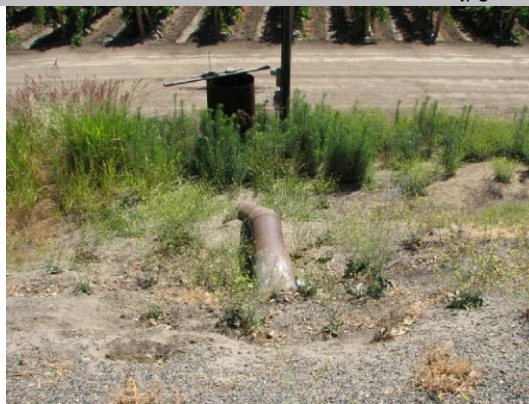
Photo 2 of 3 : UCIP_SP_2018_5172_6982.jpg

LM Start	13.85	Rating **	M	Issue No.	1823 (cont)
LM End	13.85	Issue Type +	En	Location *

36-inch standpipe, JP, and meter on LS toe.

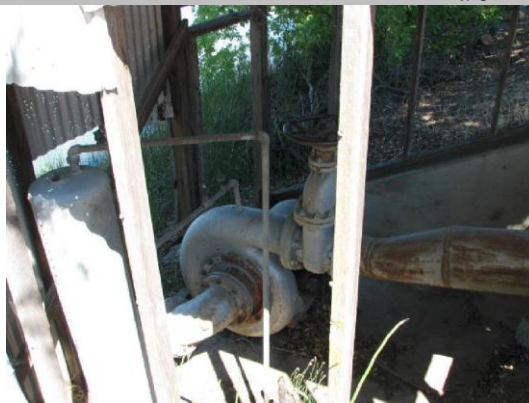
Photo 3 of 3 : UCIP_SP_2018_5172_6981.jpg

LM Start	13.85	Rating **	M	Issue No.	1823 (cont)	
LM End	13.85	Issue Type +	En	Location *		
Category	Supplemental			GPS Latitude/Longitude		
				Start		End
Item	DWR UCIP Field Study			38.416180 °		38.416180 °
				-121.521083 °		-121.521083 °
DWR ID						
Comment Code						
Inspector Comment						
FS_ID:5172 DS_ID:17474 EP_NO: N/A Repair Type: Non-Urgent Crossing Status: Found UCIP Comments: Rodent undermining pipe on LS slope. Need to fill burrow with flowable fill. FIELD_STRUCT_DESC: 14-inch pipe through levee, 5.2 feet below crown. 12-inch sleeved through 14-inch with annular space grouted. Pump and gate valve in pump house on waterward slope. Service pole on landward slope. 36-inch steel standpipe at toe of landward slope. Originally included in O+M manual (1955). 1.5-inch steel electrical conduit through levee and parallel to 14-inch pipe. FS Date: 6/25/2012 10:08:16 AM

Pump and gate valve in pumphouse on WS slope.

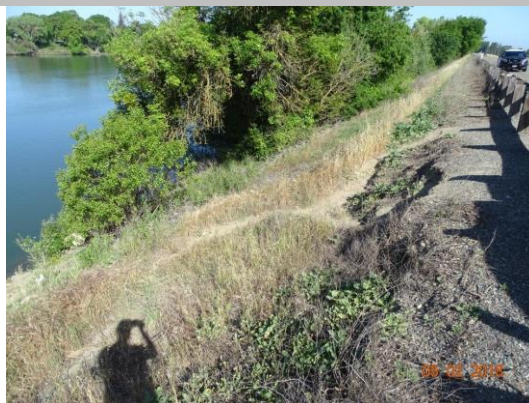
Photo 1 of 2 : SP_2018_MA0009_201_265_20180502_00525.jpg

LM Start	13.96	Rating **	M	Issue No.	265
LM End	13.96	Issue Type +	Ma	Location *	WS
Category	Earthen Levee			GPS Latitude/Longitude	
				Start	End
Item	Erosion / Bank Caving			38.414860 °	38.414860 °
				-121.520095 °	-121.520095 °
DWR ID	DWR_MA0009_01_s_2018_265				
Comment Code					
E2 : Schedule repair of erosion site prior to the next inspection.					
Inspector Comment					
Runoff and slope stability site. It appears to be an active fishing spot.

View of erosion site on waterside slope. Spring 2018.

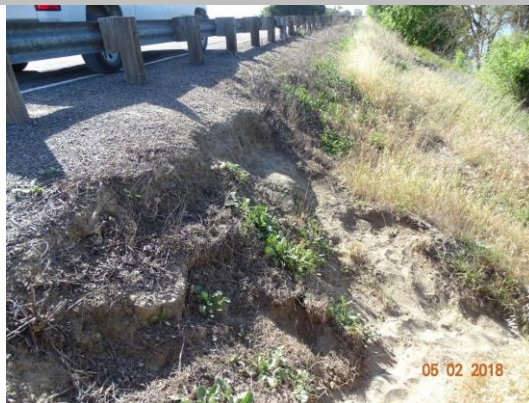
Photo 2 of 2 : SP_2018_MA0009_201_265_20180502_00526.jpg

LM Start	13.96	Rating **	M	Issue No.	265 (cont)
LM End	13.96	Issue Type +	Ma	Location *	WS

Additional view of erosion. Spring 2018.

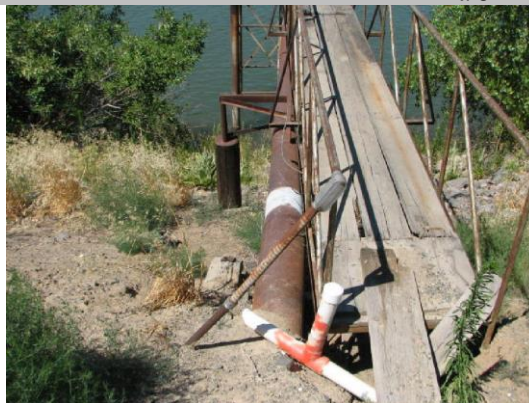
Photo 1 of 3 : UCIP_SP_2018_5174_6987.jpg

Comment Code						
Inspector Comment						
FS_ID:5174 DS_ID:17475 EP_NO: N/A Repair Type: Non-Urgent Crossing Status: Found UCIP Comments: Annular space between 12-inch and 14-inch pipes needs to be grouted. Siphon breaker on LS shoulder appears to be damaged. No permit identified for this crossing and it is not noted in the O+M manual. FIELD_STRUCT_DESC: 14-inch pipe through levee, 2.6 feet below crown. 12-inch pipe on WS connected to 14-inch pipe through levee. Pump on pile structure in stream. 1.5-inch steel electrical conduit through levee and parallel to 14-inch pipe. Siphon breaker in 24-inch CMP riser on LS shoulder. Pole, meter, and 36-inch concrete standpipe on LS toe. Permit No. 1835, 1953. FS Date: 6/25/2012 10:19:35 AM

12-inch steel pipe through 14-inch steel conduit on WS shoulder at pier.
1.5-inch steel electrical conduit.

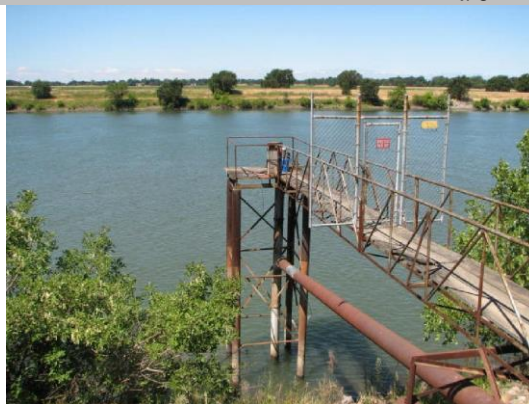
Photo 2 of 3 : UCIP_SP_2018_5174_6986.jpg

LM Start	14.24	Rating **	M	Issue No.	1824 (cont)
LM End	14.24	Issue Type +	En	Location *

12-inch pipe on pier WS.

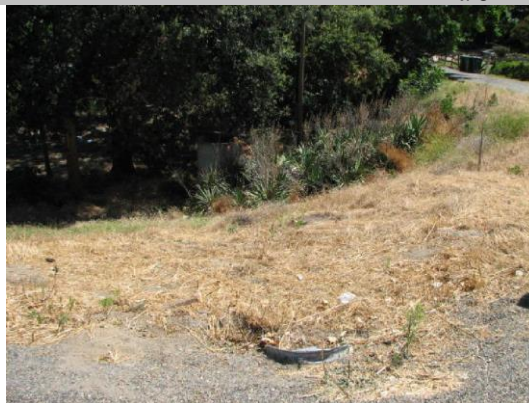
Photo 3 of 3 : UCIP_SP_2018_5174_6985.jpg

Item	DWR UCIP Field Study			38.411280 °	38.411280 °	
				-121.517510 °	-121.517510 °	
DWR ID						
Comment Code						
Inspector Comment						
FS_ID:5174 DS_ID:17475 EP_NO: N/A Repair Type: Non-Urgent Crossing Status: Found UCIP Comments: Annular space between 12-inch and 14-inch pipes needs to be grouted. Siphon breaker on LS shoulder appears to be damaged. No permit identified for this crossing and it is not noted in the O+M manual. FIELD_STRUCT_DESC: 14-inch pipe through levee, 2.6 feet below crown. 12-inch pipe on WS connected to 14-inch pipe through levee. Pump on pile structure in stream. 1.5-inch steel electrical conduit through levee and parallel to 14-inch pipe. Siphon breaker in 24-inch CMP riser on LS shoulder. Pole, meter, and 36-inch concrete standpipe on LS toe. Permit No. 1835, 1953. FS Date: 6/25/2012 10:19:35 AM

siphon breaker in damaged 24-inch CMP riser on LS shoulder (in foreground)

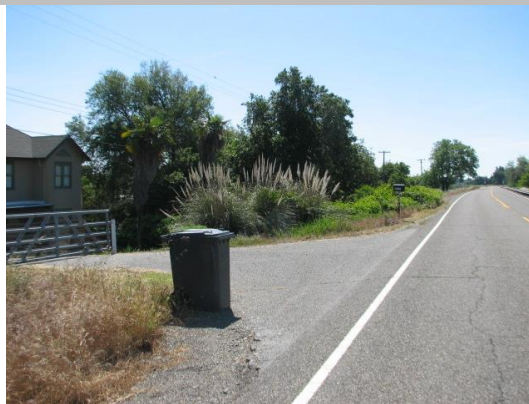
Photo 1 of 2 : SP_2018_MA0009_201_205_20180306_00155.jpg

LM Start	14.27	Rating **	M	Issue No.	205
LM End	14.27	Issue Type +	En	Location *	LS
Category	Earthen Levee			GPS Latitude/Longitude	
				Start	End
Item	Vegetation			38.410947 °	38.410947 °
				-121.517202 °	-121.517202 °
DWR ID	DWR_MA0009_01_s_2012_205				
Comment Code					
V6 : Landscaping					
Inspector Comment

Looking downstream at the landscaping on the levee slope. Spring 2014

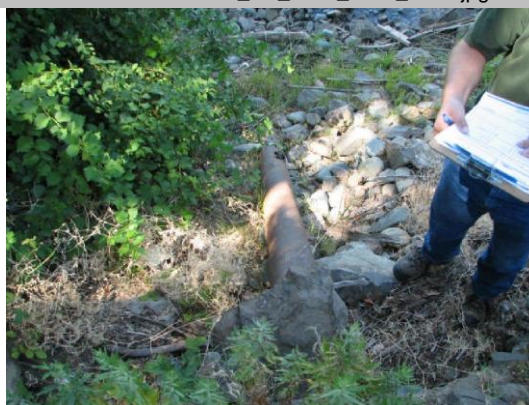
Photo 1 of 1 : UCIP_SP_2018_5175_6989.jpg

LM Start	14.28	Rating **	M	Issue No.	1825	
LM End	14.28	Issue Type +	En	Location *		
Category	Supplemental			GPS Latitude/Longitude		
				Start	End	
Item	DWR UCIP Field Study			38.410811 °	38.410811 °	
				-121.517144 °	-121.517144 °	
DWR ID						
Comment Code						
Inspector Comment						
FS_ID:5175						
DS_ID:17575						
EP_NO: N/A						
Repair Type: Non-Urgent						
Crossing Status: Found						
UCIP Comments: Type of abandonment needs to be determined.						
FIELD_STRUCT_DESC: 6-inch pipe through the levee 6.1-feet below the crown and visible on WS toe. Pump on water side removed.						
Originally included in O+M manual (1955).						
FS Date: 6/25/2012 10:35:04 AM

cut-off pipe at WS toe/slope. No indication pipe goes through levee.

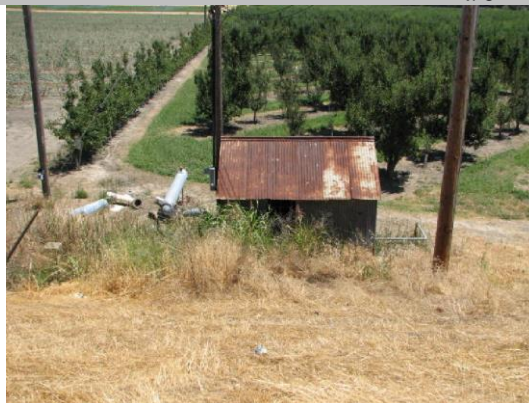
Photo 1 of 3 : UCIP_SP_2018_51704_6999.jpg

LM Start	14.64	Rating **	U	Issue No.	1826	
LM End	14.64	Issue Type +	En	Location *		
Category	Supplemental			GPS Latitude/Longitude		
				Start	End	
Item	DWR UCIP Field Study			38.406118 °	38.406118 °	
				-121.514463 °	-121.514463 °	
DWR ID						
Comment Code						
Inspector Comment						
FS_ID:51704						
DS_ID:17466						
EP_NO: N/A						
Repair Type: Urgent						
Crossing Status: Found						
UCIP Comments: 04/26/2017 As per DWR inspector, Zack Jojola, the pump associated with this pipe appears to be leaking. Crossing has been upgraded from No Action Needed to Urgent. (K. Fazel - UCIP)						
FIELD_STRUCT_DESC: 12-inch pipe through levee, 10.5 feet below crown. Pump on pump house on landward side. Originally included in O+M manual (1955). JP and meter at LS toe.						
FS Date: 4/26/2017 11:17:00 AM

Pumphouse, JP, and meter on LS toe.

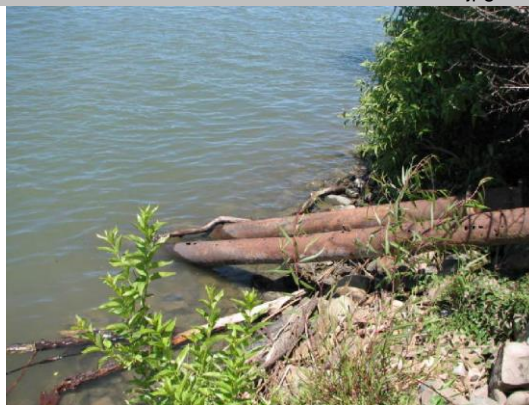
Photo 2 of 3 : UCIP_SP_2018_51704_6998.jpg

LM Start	14.64	Rating **	U	Issue No.	1826 (cont)
LM End	14.64	Issue Type +	En	Location *

8-inch pipe and discarded 8-inch pipe on WS toe.

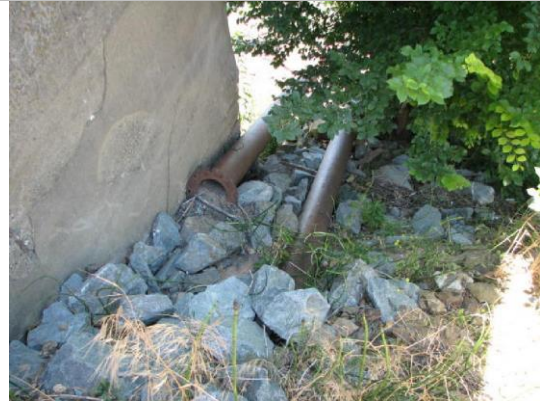
Photo 3 of 3 : UCIP_SP_2018_51704_7001.jpg

LM Start	14.64	Rating **	U	Issue No.	1826 (cont)	
LM End	14.64	Issue Type +	En	Location *		
Category	Supplemental			GPS Latitude/Longitude		
				Start	End	
Item	DWR UCIP Field Study			38.406118 °	38.406118 °	
				-121.514463 °	-121.514463 °	
DWR ID						
Comment Code						
Inspector Comment						
FS_ID:51704						
DS_ID:17466						
EP_NO: N/A						
Repair Type: Urgent						
Crossing Status: Found						
UCIP Comments: 04/26/2017 As per DWR inspector, Zack Jojola, the pump associated with this pipe appears to be leaking. Crossing has been upgraded from No Action Needed to Urgent. (K. Fazel - UCIP)						
FIELD_STRUCT_DESC: 12-inch pipe through levee, 10.5 feet below crown. Pump on pump house on landward side. Originally included in O+M manual (1955). JP and meter at LS toe.						
FS Date: 4/26/2017 11:17:00 AM

8-inch pipe at US side of concrete pumphouse.

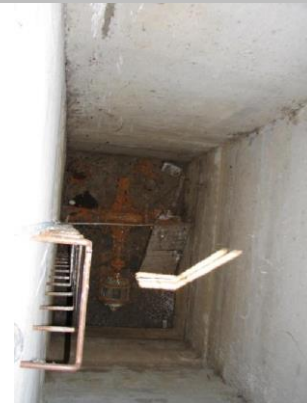
Photo 1 of 3 : UCIP_SP_2018_51705_6995.jpg

Comment Code					
Inspector Comment					
FS_ID:51705 DS_ID:17441 EP_NO: N/A Repair Type: Urgent Crossing Status: Found UCIP Comments: 04/26/2017 04/26/2017 As per DWR inspector, Zack Jojola, the pump associated with this pipe appears to be leaking. Crossing has been upgraded from No Action Needed to Urgent. (K. Fazel - UCIP)06/25/2012 Further evaluation should be conducted to determine if 12-inch pipe through levee has been properly abandoned. Pipe rusted through at bottom of pumphouse. (G. Wylie - FPIIB) FIELD_STRUCT_DESC: *ABANDONED* 12-inch pipe through levee, 9.5 feet below crown. Concrete pump house with pump and gate valve at bottom of pit on WS slope. Steel plate welded on waterward end could not be verified or found. Originally included in O+M manual (1955). FS Date: 4/26/2017 10:52:00 AM

Pump, pipe, and gate valve at bottom of pit in pumphouse.

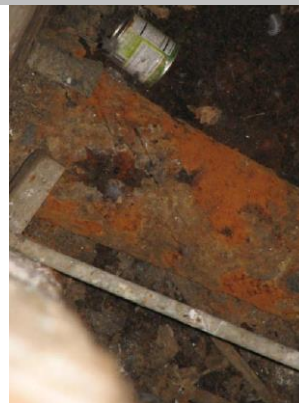
Photo 2 of 3 : UCIP_SP_2018_51705_6994.jpg

Item	DWR UCIP Field Study			38.406099 °	38.406099 °	
				-121.514458 °	-121.514458 °	
DWR ID						
Comment Code						
Inspector Comment						
FS_ID:51705 DS_ID:17441 EP_NO: N/A Repair Type: Urgent Crossing Status: Found UCIP Comments: 04/26/2017 04/26/2017 As per DWR inspector, Zack Jojola, the pump associated with this pipe appears to be leaking. Crossing has been upgraded from No Action Needed to Urgent. (K. Fazel - UCIP)06/25/2012 Further evaluation should be conducted to determine if 12-inch pipe through levee has been properly abandoned. Pipe rusted through at bottom of pumphouse. (G. Wylie - FPIIB) FIELD_STRUCT_DESC: *ABANDONED* 12-inch pipe through levee, 9.5 feet below crown. Concrete pump house with pump and gate valve at bottom of pit on WS slope. Steel plate welded on waterward end could not be verified or found. Originally included in O+M manual (1955). FS Date: 4/26/2017 10:52:00 AM

Pipe appears to be severely corroded at bottom of pumphouse pit.

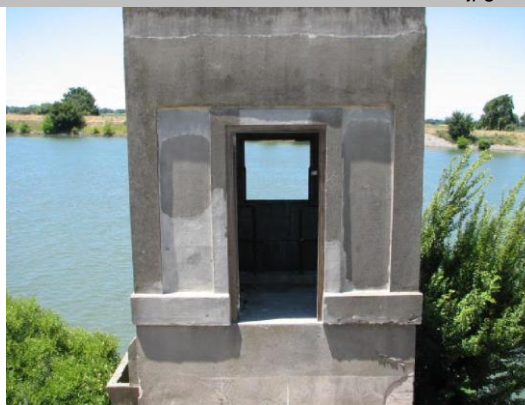
Photo 3 of 3 : UCIP_SP_2018_51705_6993.jpg

LM Start	14.64	Rating **	U	Issue No.	1827 (cont)
LM End	14.64	Issue Type +	En	Location *

Pumphouse on WS slope.

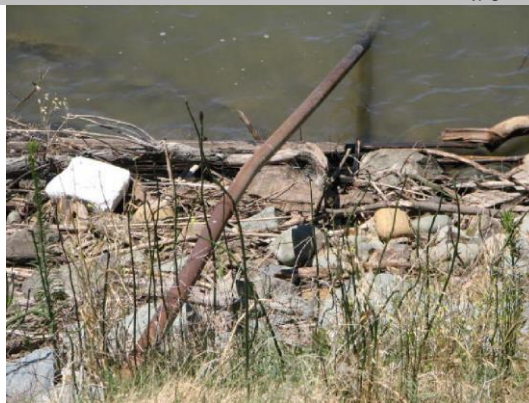
Photo 1 of 3 : UCIP_SP_2018_51462_20806.jpg

Comment Code						
Inspector Comment						
FS_ID:51462 DS_ID:17464 EP_NO: N/A Repair Type: Non-Urgent Crossing Status: Found UCIP Comments: 12/02/2016 Same as previous inspection. Need find owner. Owner will need to coordinate with the CVFPB to address what is currently logged as unauthorized encroachments. Owner will need to comply with Title 23. Dense vegetation limits the inspector's visibility to identify signs of pipe failure (leaks) along the slope. Recommend removing vegetation along pipe alignment to conduct proper inspection of structure and appurtenances. Crossing has been downgraded from "Urgent" to "Non-Urgent" due to modifications made to the UCIP repair/maintenance priority. (O. Magana - DWR UCIP)06/25/2012 No permit issued for this crossing and it is not an O+M entry. Abandoned pipe not grouted or sealed. (W. Wylie - DWR UCIP) FIELD_STRUCT_DESC: 2.25-inch steel water line through levee, 5 feet below crown. Gate valve located on the waterside (WS) slope has been removed. 2-inch steel pipe remains visible on the landside (LS) slope parallel to new 2.25-inch steel pipe. Pump house is located on the LS toe. [Additional Reference(s): DWR Levee Log, 1991]. FS Date: 12/2/2016

LM Start	14.73	Rating **	M	Issue No.	1828 (cont)
LM End	14.73	Issue Type +	En	Location *

2.25-inch pipe at waterline.

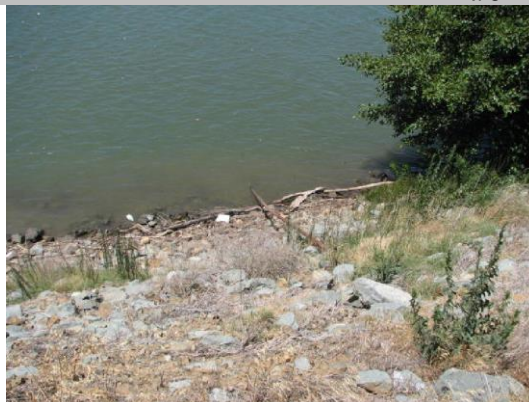
Photo 2 of 3 : UCIP_SP_2018_51462_20805.jpg

View of pipe from WS shoulder.

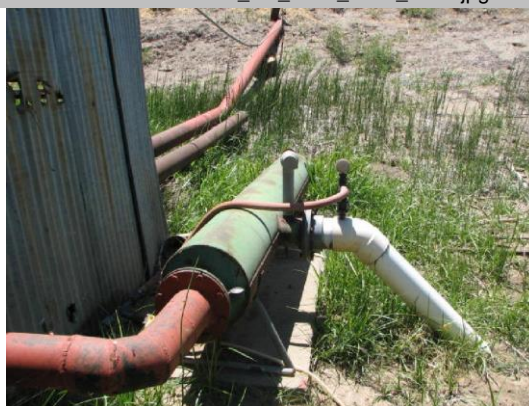
Photo 3 of 3 : UCIP_SP_2018_5180_7002.jpg

Distribution system on LS toe.

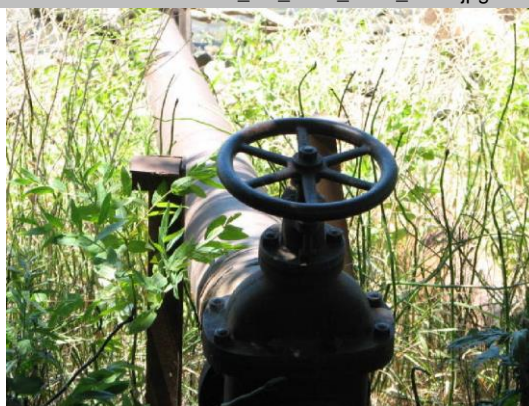
Photo 2 of 3 : UCIP_SP_2018_5181_7007.jpg

Close up of Gate valve on WS slope.

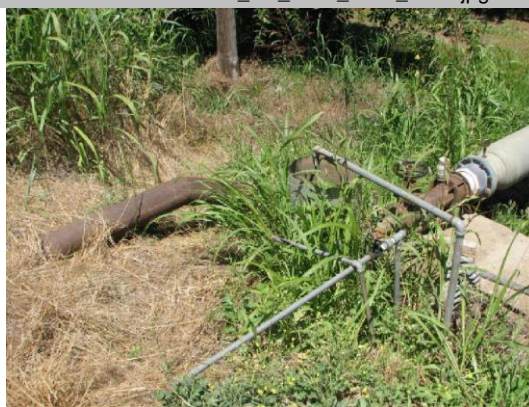
Photo 3 of 3 : UCIP_SP_2018_5181_7006.jpg

Pump, pipe, and appurtances on LS toe.

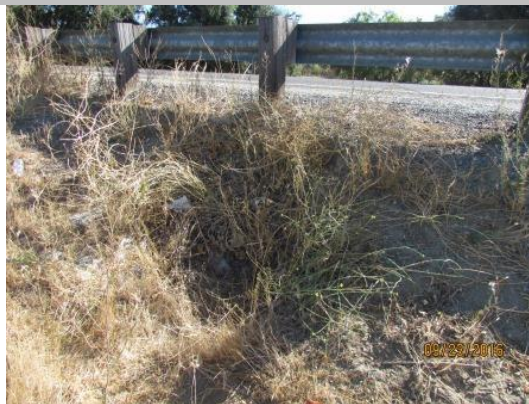
Photo 1 of 1 : SP_2018_MA0009_201_256_20180306_00206.jpg

LM Start	15.55	Rating **	M	Issue No.	256
LM End	15.55	Issue Type +	Ma	Location *	WS
Category	Earthen Levee			GPS Latitude/Longitude	
				Start	End
Item	Slope Stability			38.393089 °	38.393089 °
				-121.512233 °	-121.512233 °
DWR ID	DWR_MA0009_01_f_2016_256				
Comment Code					
S1 : Repair slope instability.					
Inspector Comment					
Slope stability may be caused by pipe on WS toe of the levee. Recommend backfilling dirot.

At least 1-foot-deep cave found near a UCIP pipe on WS slope. Fall 2016.

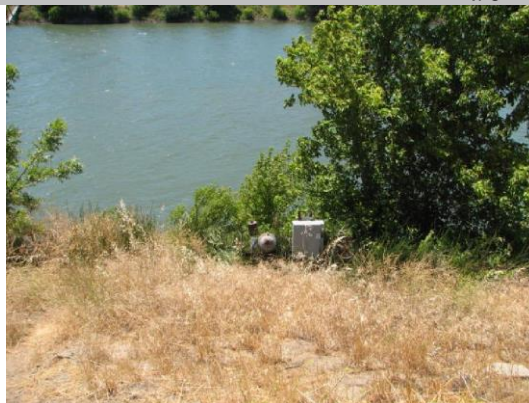
Photo 1 of 3 : UCIP_SP_2018_51465_20809.jpg

Comment Code					
Inspector Comment					
FS_ID:51465 DS_ID:17431 EP_NO: N/A Repair Type: Urgent Crossing Status: Found UCIP Comments: 12/02/2016 Assumed same condition as last inspection--unable to verify damage reported during last inspection due to limited access to both WS and LS (steep slopes--safety issue). Crossing remains "Urgent" due to signs of sink hole/burrow activity visible along WS pipe alignment. Need to contact owner. Recommend internal integrity inspection be performed at this crossing to determine condition of pipe through the levee. (O. Magana - DWR UCIP)06/25/2012 2-foot deep 5-foot diameter sink hole over pipe at LS shoulder. Pipe has multiple repairs and leaks along water side slope. gate valve is in-operative. Pipe is likely failing internally. (W. Wylie - DWR UCIP) FIELD_STRUCT_DESC: 12-inch steel irrigation pipe through levee, 17 feet below crown. Pump and gate valve on concrete stand box are located on the landside (LS) toe. Slant pump and 10-inch pipe sleeved into 12-inch pipe located on the waterside (WS) slope. [Additional Reference(s): DWR Levee Log, 1991. USACE Sacramento O&M Manual Unit 111, May 1959 (River Mile 40.34)]. FS Date: 12/2/2016

Slant pump on WS slope.

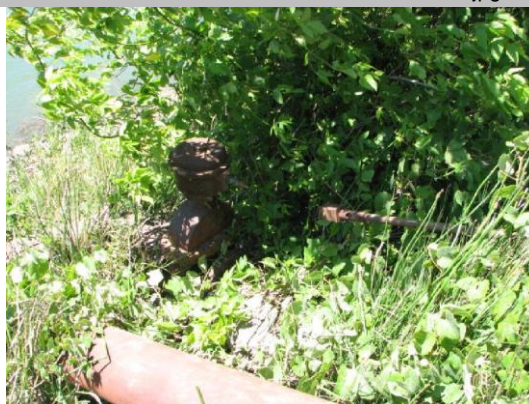
Photo 2 of 3 : UCIP_SP_2018_51465_20808.jpg

Gate valve missing handle.

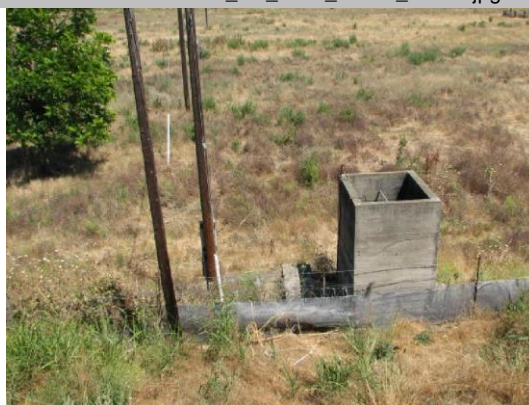
Photo 3 of 3 : UCIP_SP_2018_51256_20812.jpg

Pipe, JP, meter, and concrete distribution box on LS toe.

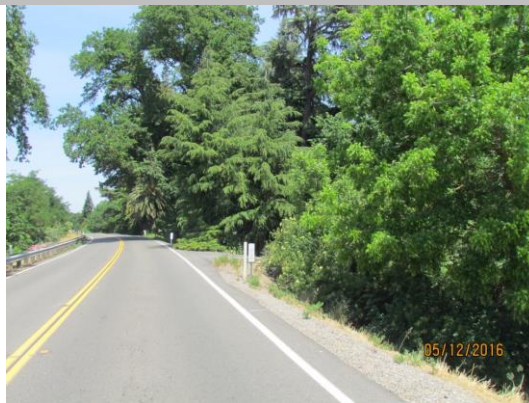
Photo 1 of 1 : SP_2018_MA0009_201_202_20180306_00154.jpg

LM Start	16.03	Rating **	M	Issue No.	202
LM End	16.12	Issue Type +	En	Location *	LS
Category	Earthen Levee			GPS Latitude/Longitude	
				Start	End
Item	Vegetation			38.386420 °	38.385235 °
				-121.514125 °	-121.515025 °
DWR ID	DWR_MA0009_01_s _ 2012_202				
Comment Code					
V6 : Landscaping					
Inspector Comment					
Rosebud and house upstream

View of the trees on the landward slope of the levee looking upstream.
Spring 2016.

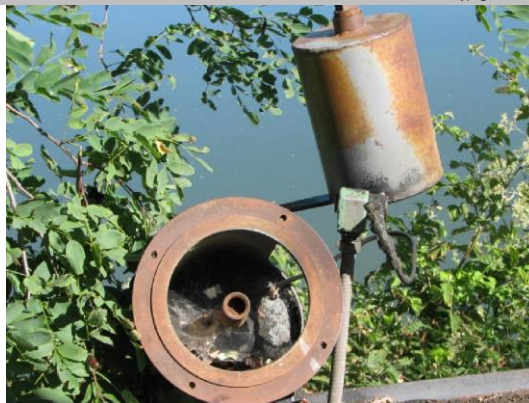
Photo 3 of 3 : UCIP_SP_2018_5186_7021.jpg

Missing pump.

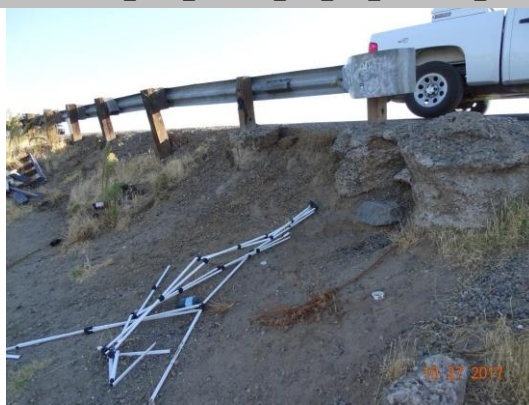
Photo 1 of 1 : SP_2018_MA0009_201_433_20180306_00316.jpg

LM Start	16.80	Rating **	M	Issue No.	433
LM End	16.80	Issue Type +	Ma	Location *	WS
Category	Earthen Levee			GPS Latitude/Longitude	
				Start	End
Item	Erosion / Bank Caving			38.378335 °	38.378335 °
				-121.523509 °	-121.523509 °
DWR ID	DWR_MA0009_01_f_2017_433				
Comment Code					
E2 : Schedule repair of erosion site prior to the next inspection.					
Inspector Comment					
Runoff erosion at waterside hinge point.

View of erosion at hinge point. Fall 2017.

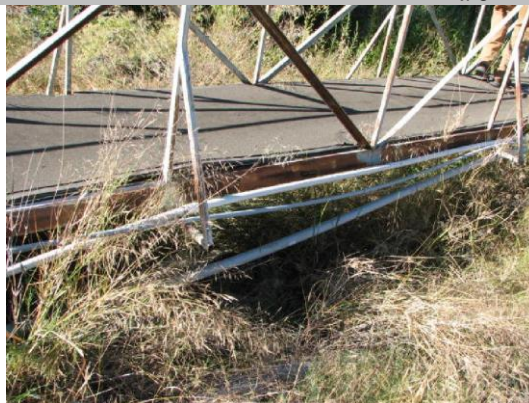
Photo 1 of 2 : UCIP_SP_2018_5929_9022.jpg

LM Start	17.10	Rating **	M	Issue No.	1837
LM End	17.10	Issue Type +	En	Location *	
Category	Supplemental			GPS Latitude/Longitude	
				Start	End
Item	DWR UCIP Field Study			38.374100 °	38.374100 °
				-121.522350 °	-121.522350 °
DWR ID					
Comment Code					
Inspector Comment					
FS_ID:5929 DS_ID:18960 EP_NO: N/A Repair Type: Non-Urgent Crossing Status: Found UCIP Comments: No permit identified for this crossing. FIELD_STRUCT_DESC: 1.25-inch polyvinyl chloride (PVC) pipe of an unknown purpose through the levee, 6 feet below the crown, at the upstream side of the boat ramp walkway. FS Date: 6/26/2012 3:56:24 PM

Pipe on upstream side of pier walkway.

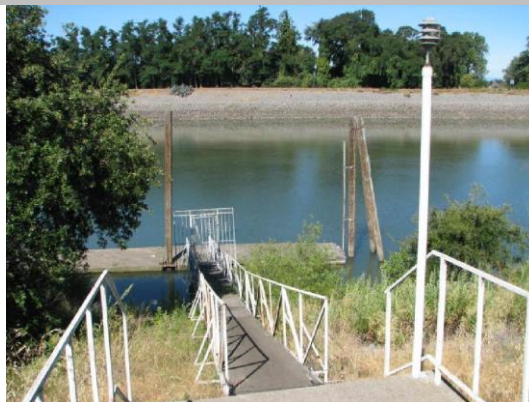
Photo 2 of 2 : UCIP_SP_2018_5929_9021.jpg

Pier on WS shoulder.

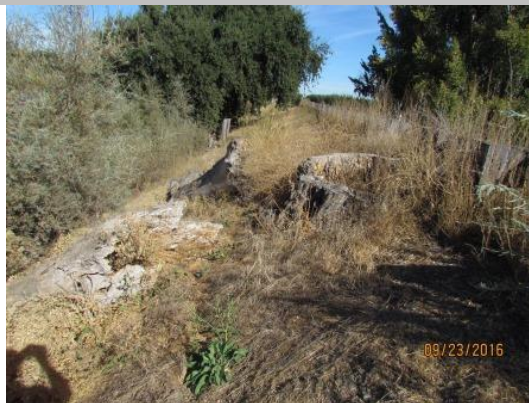
Photo 1 of 1 : SP_2018_MA0009_201_258_20180306_00207.jpg

LM Start	17.18	Rating **	N	Issue No.	258
LM End	17.18	Issue Type +	Ma	Location *	WS
Category	Earthen Levee			GPS Latitude/Longitude	
				Start	End
Item	Trim / Thin Trees			38.373060 °	38.373060 °
				-121.521868 °	-121.521868 °
DWR ID	DWR_MA0009_01_f_2016_258				
Comment Code					
T5 : Tree stumps.					
Inspector Comment					
May pose threat to the levee in future.

Decomposing tree body and root on waterside slope looking upstream.
Fall 2016.

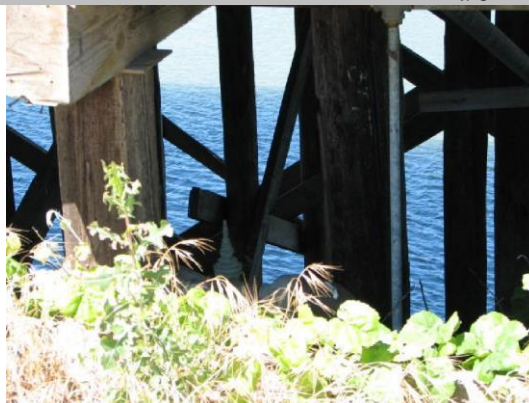
Photo 2 of 3 : UCIP_SP_2018_5933_9042.jpg

LM Start	17.49	Rating **	M	Issue No.	1842 (cont)
LM End	17.49	Issue Type +	En	Location *	
Category	Supplemental			GPS Latitude/Longitude	
				Start	End
Item	DWR UCIP Field Study			38.368740 °	38.368740 °
				-121.520400 °	-121.520400 °
DWR ID					
Comment Code					
Inspector Comment					
FS_ID:5933 DS_ID:18964 EP_NO: N/A Repair Type: Non-Urgent Crossing Status: Found UCIP Comments: No permit identified for this crossing. FIELD_STRUCT_DESC: 4-inch steel water line through the levee, 3.5 feet below the crown. Shutoff valve on the waterside (WS) slope under building. FS Date: 6/26/2012 4:02:26 PM

Valve sticking up under building on WS slope.

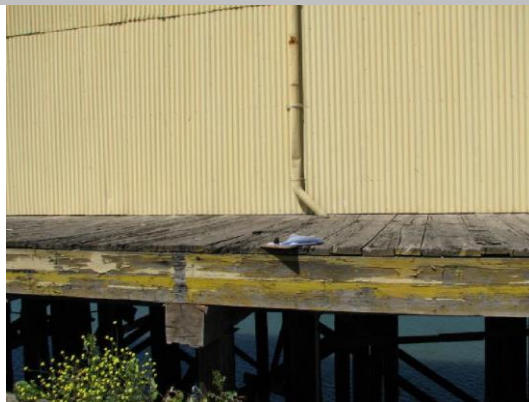
Photo 3 of 3 : UCIP_SP_2018_5933_9041.jpg

Building at waterside slope.

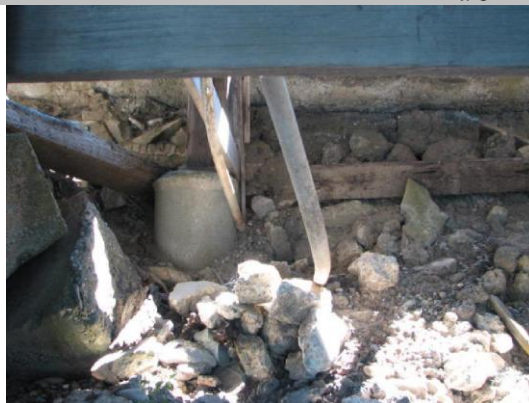
Photo 1 of 2 : UCIP_SP_2018_5934_9045.jpg

LM Start	17.50	Rating **	M	Issue No.	1843
LM End	17.50	Issue Type +	En	Location *	
Category	Supplemental			GPS Latitude/Longitude	
				Start	End
Item	DWR UCIP Field Study			38.368590 °	38.368590 °
				-121.520310 °	-121.520310 °
DWR ID					
Comment Code					
Inspector Comment					
FS_ID:5934 DS_ID:18965 EP_NO: N/A Repair Type: Non-Urgent Crossing Status: Found UCIP Comments: No permit identified for this crossing. FIELD_STRUCT_DESC: 2.5-inch steel electrical conduit through the levee, 6 feet below the crown. Pipe visible under building on the waterside (WS) slope. FS Date: 6/26/2012 4:04:34 PM

Pipes through levee on WS slope.

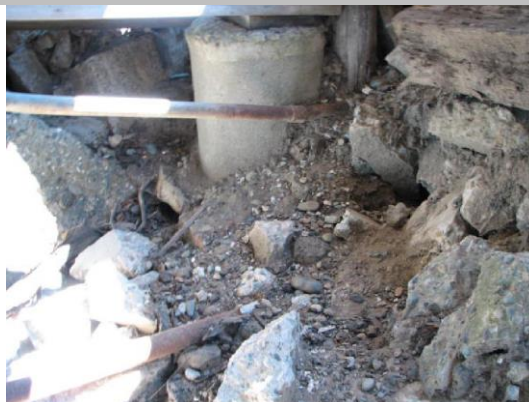
Photo 2 of 2 : UCIP_SP_2018_5934_9044.jpg

Pipes through levee on WS slope.

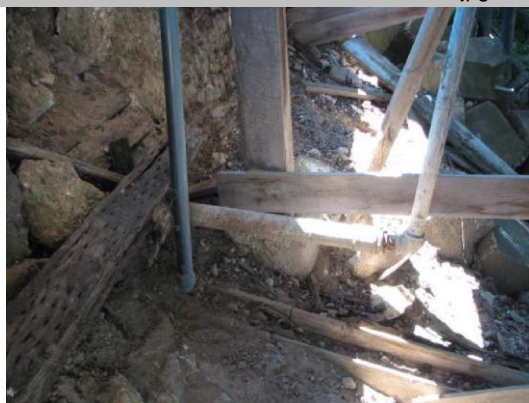
Photo 1 of 2 : UCIP_SP_2018_5937_9050.jpg

LM Start	17.50	Rating **	M	Issue No.	1846
LM End	17.50	Issue Type +	En	Location *	
Category	Supplemental			GPS Latitude/Longitude	
				Start	End
Item	DWR UCIP Field Study			38.368560 °	38.368560 °
				-121.520300 °	-121.520300 °
DWR ID					
Comment Code					
Inspector Comment					
FS_ID:5937 DS_ID:18967 EP_NO: N/A Repair Type: Non-Urgent Crossing Status: Found UCIP Comments: No permit identified for this crossing. FIELD_STRUCT_DESC: 4-inch steel water line through the levee, 5 feet below the crown. Pipe visible under building on the waterside (WS) slope. FS Date: 6/26/2012 4:08:42 PM

Pipes through levee on WS slope.

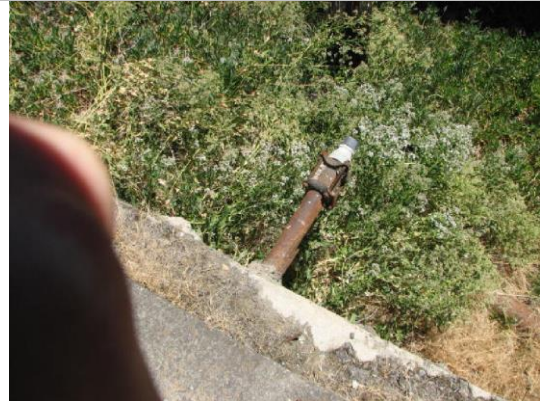
Photo 2 of 2 : UCIP_SP_2018_5937_9049.jpg

LM Start	17.50	Rating **	M	Issue No.	1846 (cont)
LM End	17.50	Issue Type +	En	Location *	
Category	Supplemental			GPS Latitude/Longitude	
				Start	End
Item	DWR UCIP Field Study			38.368560 °	38.368560 °
				-121.520300 °	-121.520300 °
DWR ID					
Comment Code					
Inspector Comment					
FS_ID:5937 DS_ID:18967 EP_NO: N/A Repair Type: Non-Urgent Crossing Status: Found UCIP Comments: No permit identified for this crossing. FIELD_STRUCT_DESC: 4-inch steel water line through the levee, 5 feet below the crown. Pipe visible under building on the waterside (WS) slope. FS Date: 6/26/2012 4:08:42 PM

Pipe exiting from concret wall on LS shoulder.

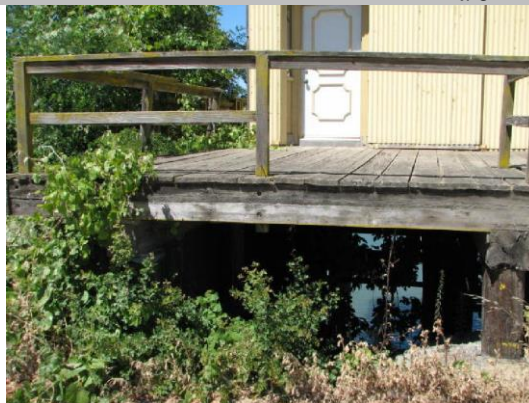
Photo 2 of 2 : UCIP_SP_2018_5938_9051.jpg

LM Start	17.52	Rating **	M	Issue No.	1847 (cont)					
LM End	17.52	Issue Type +	En	Location *						
Category	Supplemental		GPS Latitude/Longitude							
			Start	End						
Item	DWR UCIP Field Study		38.368270 °	38.368270 °						
			-121.520220 °	-121.520220 °						
DWR ID										
Comment Code										
Inspector Comment										
FS_ID:5938 DS_ID:18969 EP_NO: N/A Repair Type: Non-Urgent Crossing Status: Found UCIP Comments: No permit identified for this crossing. FIELD_STRUCT_DESC: 4-inch cast iron sewer line through the levee, 2.5 feet below the crown. Pipe visible under building on the waterside (WS) slope. FS Date: 6/26/2012 4:10:08 PM

Pipe under south corner of building on WS slope.

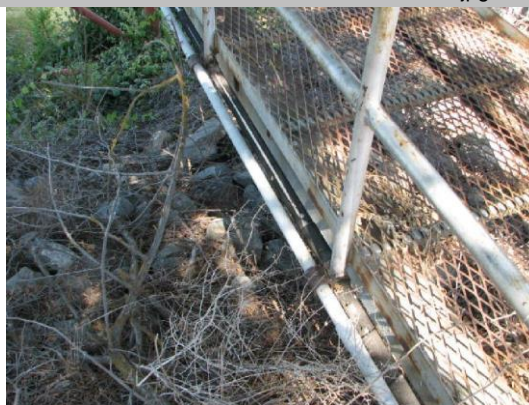
Photo 1 of 2 : UCIP_SP_2018_5939_9054.jpg

LM Start	17.57	Rating **	M	Issue No.	1848					
LM End	17.57	Issue Type +	En	Location *						
Category	Supplemental		GPS Latitude/Longitude							
			Start	End						
Item	DWR UCIP Field Study		38.367650 °	38.367650 °						
			-121.520040 °	-121.520040 °						
DWR ID										
Comment Code										
Inspector Comment										
FS_ID:5939 DS_ID:18963 EP_NO: N/A Repair Type: Non-Urgent Crossing Status: Found UCIP Comments: No permit identified for this crossing. FIELD_STRUCT_DESC: 1-inch polyvinyl chloride (PVC) domestic water line through the levee, 1.5 feet below the crown. Pipe runs from corner of building to pump house catwalk on the waterside (WS) shoulder. FS Date: 7/25/2012 4:11:55 PM

PVC waterline on downstream side of pier walkway.

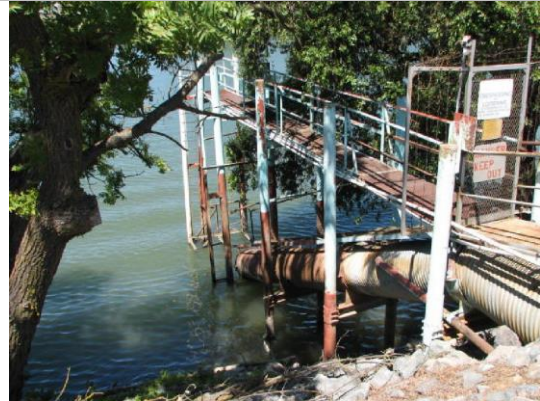
Photo 1 of 3 : UCIP_SP_2018_51466_20815.jpg

FS_ID:51466
DS_ID:17682
EP_NO: 9635
Repair Type: Urgent
Crossing Status: Found
UCIP Comments: 12/02/2016 Sink hole has developed in the last few weeks according to LMA representative. Hole through pipe section was also observed during inspection. Need to contact owner to inform owner of pipe failure and to stop use of crossing to avoid further damage to levee. (O. Magana - DWR UCIP)06/26/2012 No apparent closure device on pipe and pipe has no indication that it was properly abandoned. Urgent do to size of pipe. (W. Wylie - DWR UCIP)
FIELD_STRUCT_DESC: 3 of 3: 36-inch corrugated metal drainage pipe through the levee, 5 feet below the crown. Pipe runs under the pier walkway from the location of a removed fish screen test facility at the centerline of the levee back to the river. A 4-inch steel conduit runs parallel to the 36-inch pipe and terminates in the 36-inch pipe near the waterside (WS) slope. (Fish screen clogging engineering test facility with pump authorized under Permit Nos. 9635, 1974, and 9635-B, 1975 - State of California, Department of Water Resources [DWR], Central District, Delta Branch. Permit No. 9635-A, 1975 - State of California, Department of Water Resources [DWR], Central District, Delta Branch, issued for two trailers on the crown and the installation of a septic system. Facility is temporary. It should have been removed on July 1, 1977, per permit recordation, Page 29 or 76).

Pipe under pier.

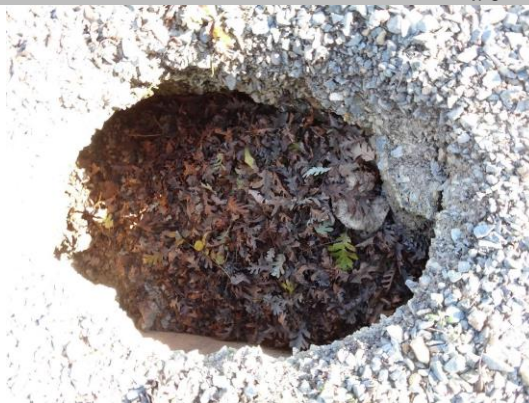
Photo 3 of 3 : UCIP_SP_2018_51466_76373.jpg

Item	DWR UCIP Field Study			38.367310 °		38.367310 °
				-121.519980 °		-121.519980 °
DWR ID						
Comment Code						
Inspector Comment						
FS_ID:51466 DS_ID:17682 EP_NO: 9635 Repair Type: Urgent Crossing Status: Found UCIP Comments: 12/02/2016 Sink hole has developed in the last few weeks according to LMA representative. Hole through pipe section was also observed during inspection. Need to contact owner to inform owner of pipe failure and to stop use of crossing to avoid further damage to levee. (O. Magana - DWR UCIP)06/26/2012 No apparent closure device on pipe and pipe has no indication that it was properly abandoned. Urgent do to size of pipe. (W. Wylie - DWR UCIP) FIELD_STRUCT_DESC: 3 of 3: 36-inch corrugated metal drainage pipe through the levee, 5 feet below the crown. Pipe runs under the pier walkway from the location of a removed fish screen test facility at the centerline of the levee back to the river. A 4-inch steel conduit runs parallel to the 36-inch pipe and terminates in the 36-inch pipe near the waterside (WS) slope. (Fish screen clogging engineering test facility with pump authorized under Permit Nos. 9635, 1974, and 9635-B, 1975 - State of California, Department of Water Resources [DWR], Central District, Delta Branch. Permit No. 9635-A, 1975 - State of California, Department of Water Resources [DWR], Central District, Delta Branch, issued for two trailers on the crown and the installation of a septic system. Facility is temporary. It should have been removed on July 1, 1977, per permit recordation, Page 29 or 76). FS Date: 12/2/2016

WS view: 2.5-feet by 3-feet sink hole present on WS.

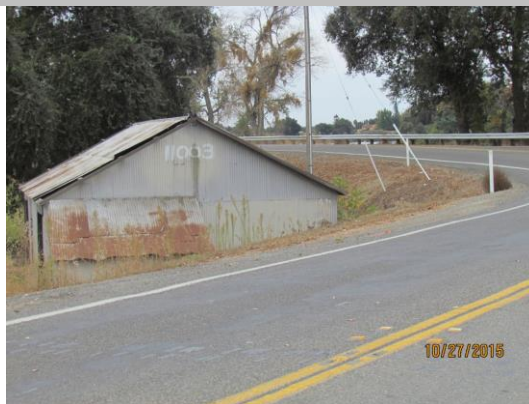
Photo 1 of 1 : SP_2018_MA0009_201_198_20180306_00150.jpg

LM Start	17.62	Rating **	M	Issue No.	198
LM End	17.62	Issue Type +	En	Location *	LS
Category	Earthen Levee			GPS Latitude/Longitude	
				Start	End
Item	Encroachments			38.366900 °	38.366900 °
				-121.520022 °	-121.520022 °
DWR ID	DWR_MA0009_01_s_2012_198				
Comment Code					
BU : Building					
Inspector Comment					
Pumphouse downstream of the Town of Hood.

View of the old pumphouse at the toe of the levee on the landward side looking downstream. Fall 2015.

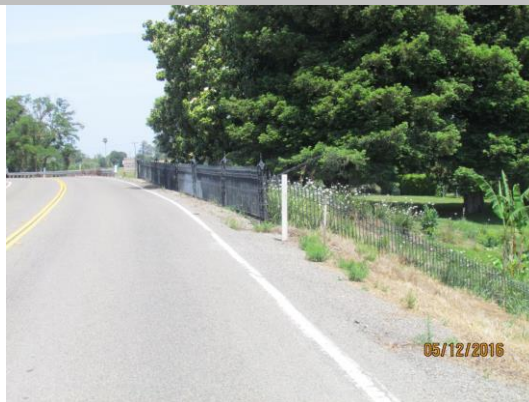
Photo 1 of 1 : SP_2018_MA0009_201_40_20180306_00028.jpg

LM Start	18.08	Rating **	M	Issue No.	40
LM End	18.08	Issue Type +	En	Location *	LS
Category	Earthen Levee			GPS Latitude/Longitude	
				Start	End
Item	Encroachments			38.360380 °	38.360380 °
				-121.520776 °	-121.520776 °
DWR ID	DWR_MA0009_01_s _ 2016_40				
Comment Code					
FE : Fence					
Inspector Comment

View of the wrought iron fence on the shoulder of the levee on the landward side looking upstream. Spring 2016.

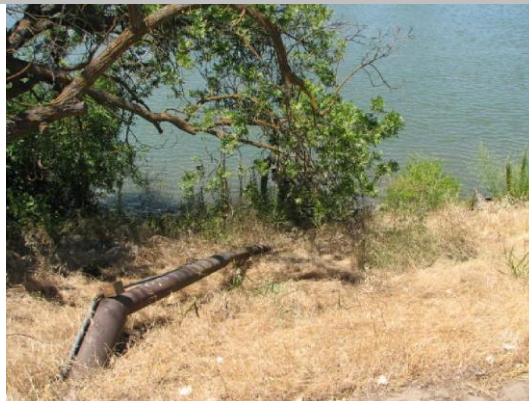
Photo 1 of 3 : UCIP_SP_2018_41064_7277.jpg

Comment Code						
Inspector Comment						
FS_ID:41064 DS_ID:17688 EP_NO: 2391 Repair Type: Non-Urgent Crossing Status: Found UCIP Comments: Pump and pipe appear to be abandoned. Need to properly abandon pipe and pump. Pier is a hazardous attractive nuisance. FIELD_STRUCT_DESC: 2 of 2: 12-inch pipe through levee, 7.3 feet below crown with an 8-inch pipe sleeved through it. Pipe and gate valve on waterward side attached to a pump on a pier. 1.25-inch galvanized steel electrical conduit through levee parallel to the 12-inch. 24-inch concrete standpipe, JP, and meter at LS toe (Permit No. 2391). Originally included in O+M manual (1955). FS Date: 6/26/2012 7:49:00 AM

12-inch with 8-inch on WS slope and 1.25-inch electrical conduit.

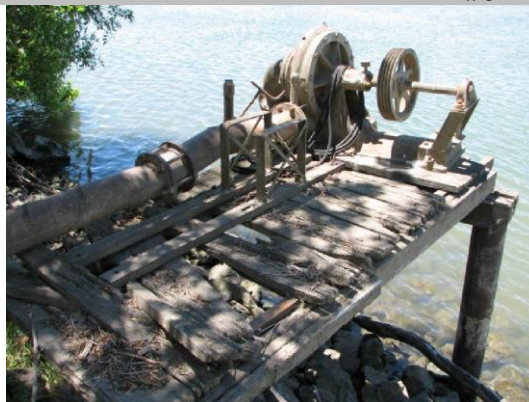
Photo 2 of 3 : UCIP_SP_2018_41064_7276.jpg

Pump on Pier on WS toe.

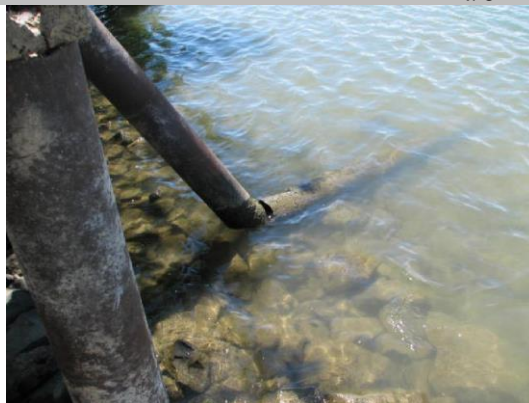
Photo 3 of 3 : UCIP_SP_2018_41064_7275.jpg

Item	DWR UCIP Field Study			38.360178	°	38.360178
				-121.521098	°	-121.521098
DWR ID						
Comment Code						
Inspector Comment						
FS_ID:41064 DS_ID:17688 EP_NO: 2391 Repair Type: Non-Urgent Crossing Status: Found UCIP Comments: Pump and pipe appear to be abandoned. Need to properly abandon pipe and pump. Pier is a hazardous attractive nuisance. FIELD_STRUCT_DESC: 2 of 2: 12-inch pipe through levee, 7.3 feet below crown with an 8-inch pipe sleeved through it. Pipe and gate valve on waterward side attached to a pump on a pier. 1.25-inch galvanized steel electrical conduit through levee parallel to the 12-inch. 24-inch concrete standpipe, JP, and meter at LS toe (Permit No. 2391). Originally included in O+M manual (1955). FS Date: 6/26/2012 7:49:00 AM

Ruptured pipe in water at WS toe.

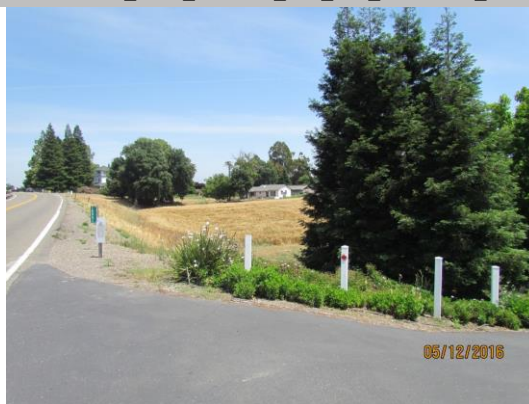
Photo 1 of 1 : SP_2018_MA0009_201_197_20180306_00149.jpg

LM Start	18.16	Rating **	M	Issue No.	197
LM End	18.16	Issue Type +	En	Location *	LS
Category	Earthen Levee			GPS Latitude/Longitude	
				Start	End
Item	Vegetation			38.359501 °	38.359501 °
				-121.521774 °	-121.521774 °
DWR ID	DWR_MA0009_01_s_2012_197				
Comment Code					
V6 : Landscaping					
Inspector Comment

View of the groundcover and redwood trees on the landward side of the levee looking upstream. Spring 2016.

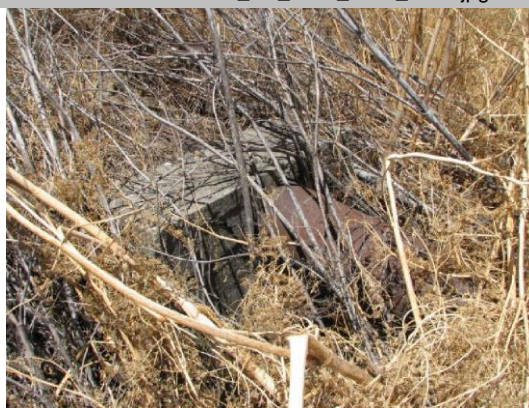
Photo 1 of 3 : UCIP_SP_2018_5305_7280.jpg

LM Start	18.22	Rating **	M	Issue No.	1851
LM End	18.22	Issue Type +	En	Location *	
Category	Supplemental			GPS Latitude/Longitude	
				Start	End
Item	DWR UCIP Field Study			38.359050 °	38.359050 °
				-121.522800 °	-121.522800 °
DWR ID					
Comment Code					
Inspector Comment					
FS_ID:5305 DS_ID:17446 EP_NO: N/A Repair Type: Non-Urgent Crossing Status: Found UCIP Comments: Could not verify welded steel plates on either end of pipe. Pipe needs to be properly abandoned. FIELD_STRUCT_DESC: *ABANDONED* 10-inch pipe through levee, 8.8 feet below crown. Steel plate welded on both ends by United States Army Corps of Engineers. Pipe visible on LS 5-feet upstream from 4X4 concrete box on LS toe. Originally included in O+M manual (1955). FS Date: 6/26/2012 8:06:32 AM

Pipe through concrete block on LS toe

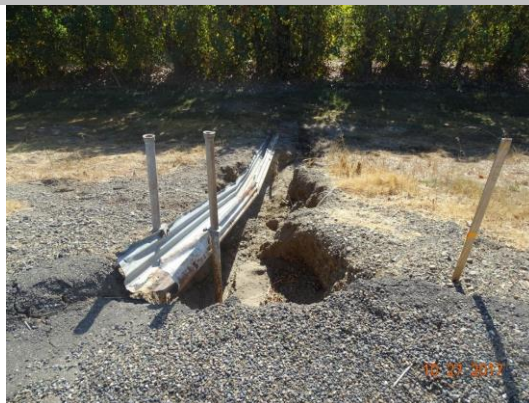
Photo 1 of 2 : SP_2018_MA0009_201_332_20180306_00265.jpg

LM Start	18.43	Rating **	U	Issue No.	332
LM End	18.43	Issue Type +	Ma	Location *	LS
Category	Earthen Levee			GPS Latitude/Longitude	
				Start	End
Item	Erosion / Bank Caving			38.357278 °	38.357278 °
				-121.525817 °	-121.525817 °
DWR ID	DWR_MA0009_01_s_2017_332				
Comment Code					
E2 : Schedule repair of erosion site prior to the next inspection.					
Inspector Comment					
Erosion on landside slope next to drainage gutter.

Updated view of erosion. Fall 2017.

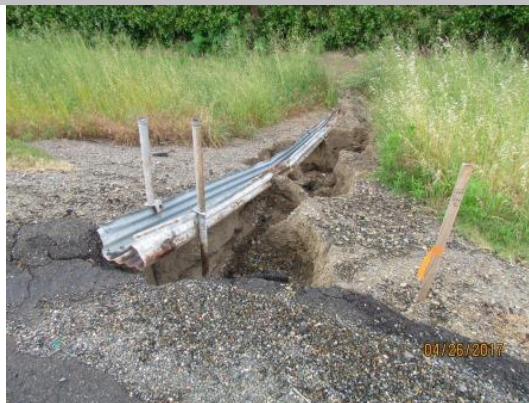
Photo 2 of 2 : SP_2018_MA0009_201_332_20180306_00266.jpg

View of erosion on landside levee slope. Spring 2017.

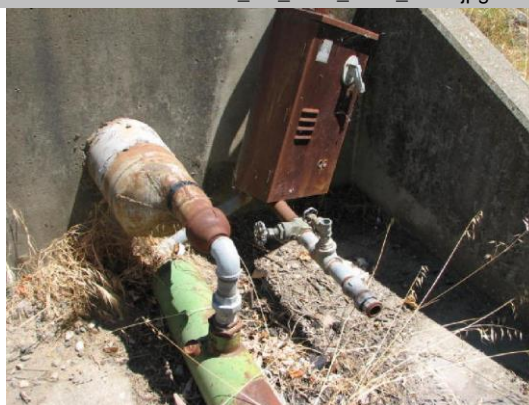
Photo 2 of 3 : UCIP_SP_2018_5311_7293.jpg

12-inch pipe with 4-inch attachment or sleeved through. Fuse box.

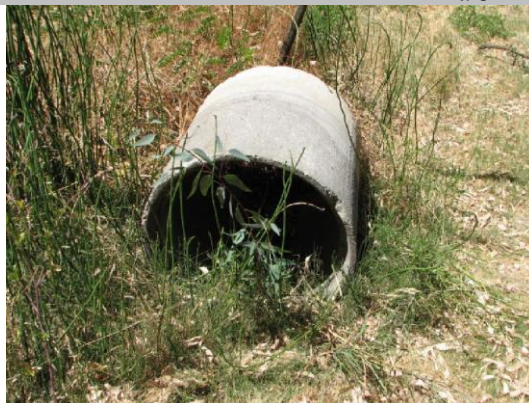
Photo 3 of 3 : UCIP_SP_2018_5311_7295.jpg

Remnants of 36-inch concrete standpipe on LS toe.

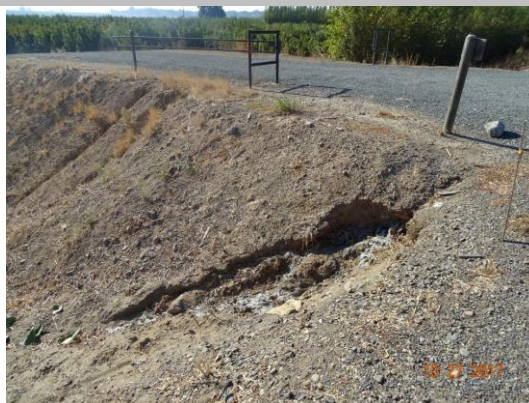
Photo 1 of 1 : SP_2018_MA0009_201_437_20180306_00317.jpg

LM Start	18.84	Rating **	M	Issue No.	437
LM End	18.84	Issue Type +	Ma	Location *	LS
Category	Earthen Levee			GPS Latitude/Longitude	
				Start	End
Item	Erosion / Bank Caving			38.352528 °	38.352528 °
				-121.530385 °	-121.530385 °
DWR ID	DWR_MA0009_01_f_2017_437				
Comment Code					
E2 : Schedule repair of erosion site prior to the next inspection.					
Inspector Comment					
Runoff erosion on landside slope and access ramp.

View of erosion on landside slope and ramp. Fall 2017.

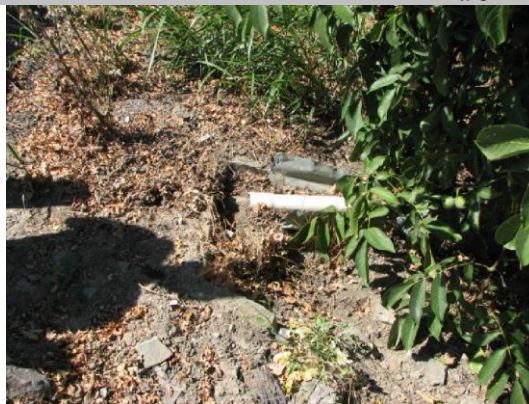
Photo 2 of 3 : UCIP_SP_2018_5780_8742.jpg

Concrete U shaped headwall at outlet showing white PVC pipe in corrugated metal sluice on WS shoulder.

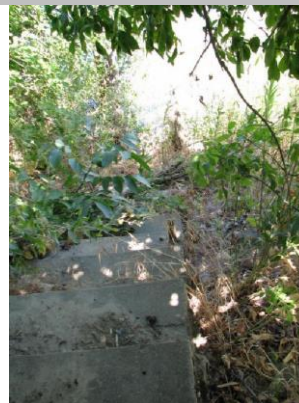
Photo 3 of 3 : UCIP_SP_2018_5780_8741.jpg

Concrete stairs on WS slope just upstream from pipe crossing.

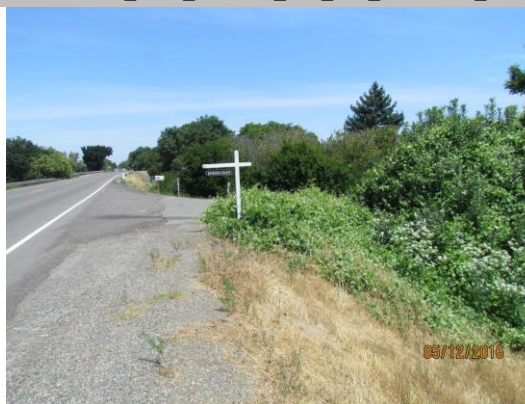
Photo 1 of 1 : SP_2018_MA0009_201_194_20180306_00147.jpg

LM Start	18.95	Rating **	M	Issue No.	194
LM End	18.95	Issue Type +	En	Location *	LS
Category	Earthen Levee			GPS Latitude/Longitude	
				Start	End
Item	Vegetation			38.351293 °	38.351293 °
				-121.531639 °	-121.531639 °
DWR ID	DWR_MA0009_01_s_2012_194				
Comment Code					
V6 : Landscaping					
Inspector Comment

View of the shrubs on the landward side of the levee looking upstream. Spring 2016.
